## **Perspectives on Hydrogen Embrittlement on Coated High Strength Fasteners**

Salim Brahimi ing.  
IBECA Technologies / McGill University

RCSC Annual Meeting  
Estes Park, Co  
June 6, 20124

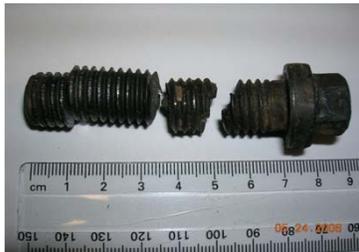
**Hydrogen Embrittlement (HE)** — a permanent loss of ductility in a metal or alloy caused by hydrogen in combination with stress, either externally applied or internal residual stress. Source: ASTM F 2078

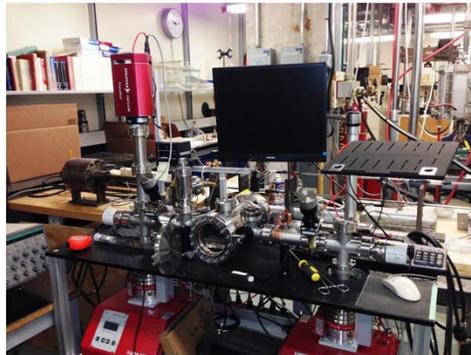
# Thermal Desorption Spectroscopy (TDS)

Measure H discharge as a function of time and temperature

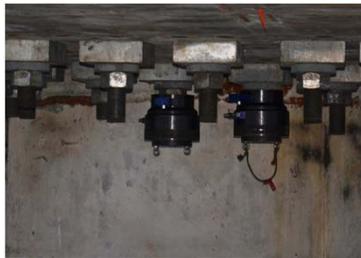
## Hydraulic Tensioning of Rods – March 2013

Target Tension

0.75  $F_u$   
→ 0.70  $F_u$

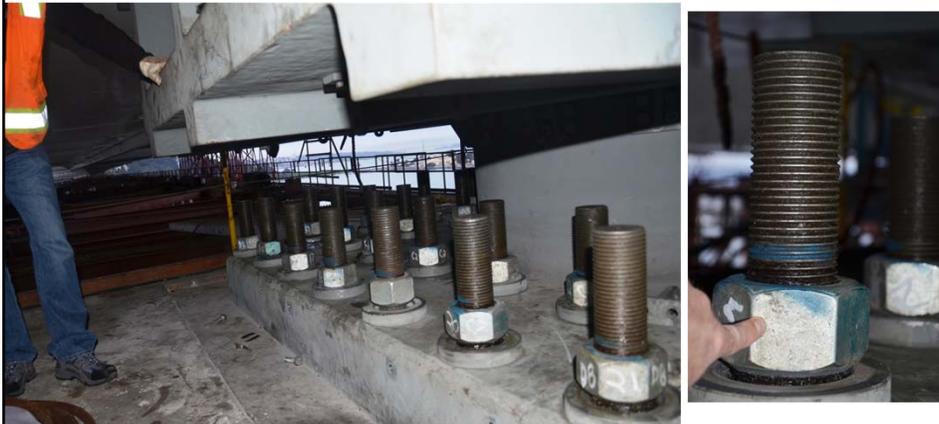
## Nut separation days after tensioning

**32 of the 96 (2008) A354 BD anchor rods on shear keys S1 /S2 on Pier E2 failed after being tightened to specified tension levels**

- The metallurgical condition of the steel was poor
  - ⇒ microstructure inhomogeneous
  - ⇒ large difference in hardness from center to edge,
  - ⇒ high local hardness near the surface
  - ⇒ Additional consequence, the material exhibits low toughness and marginal ductility
- The mechanism → hydrogen embrittlement, resulting from:
  - ⇒ Applied tensile load and
  - ⇒ Hydrogen that was already present and available in the rod material as they were tensioned
- The root cause of the failures is attributed to **higher than normal susceptibility of the steel to hydrogen embrittlement.**

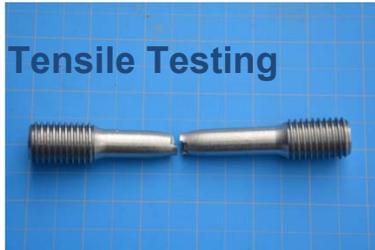
### Tensile Testing

- Material meets **yield** strength, **tensile** strength and **elongation** requirements for A354 grade BD,
- Note: elongation was marginally above the minimum of 14%.

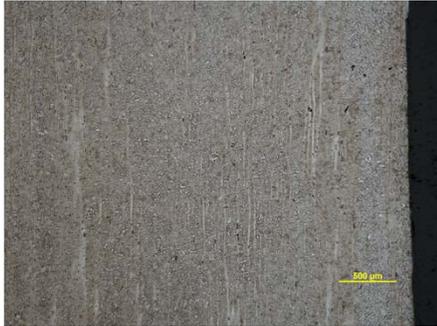
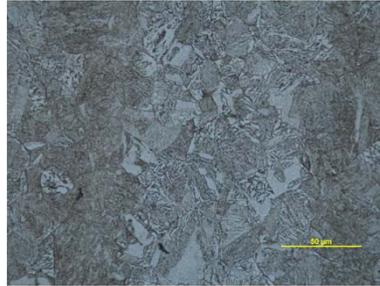
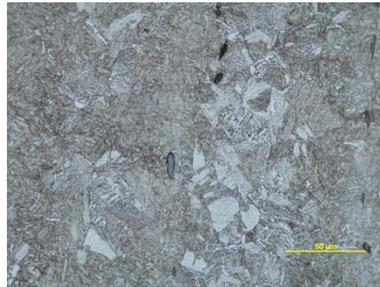
## Poor Microstructure
